# Ice Force and Scour Instrumentation for the White River, Vermont

# Special Report 96-6

Cold Regions Research &  
Engineering Laboratory

Prepared for  
STATE OF VERMONT  
and  
FEDERAL HIGHWAY ADMINISTRATION

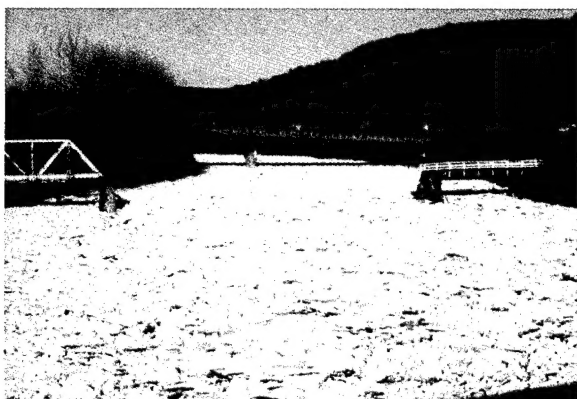
This temporary bridge lasted until January 26, 1990, when it collapsed during ice breakup. One pier collapsed first, dropping two spans into the river. Fifteen minutes later a second pier failed, dropping a third span into the river (Fig. 3). Historical flow and weather data (App. A) show that the bridge had been subjected to breakups with potentially more ice, due to lower temperatures or higher stage levels or both, than in previous

*a. Looking downstream.*

*b. Looking upstream. The Route 5 bridge is in the background.*

*Figure 3. Failure of the Bridge Street bridge, January 26, 1990.*

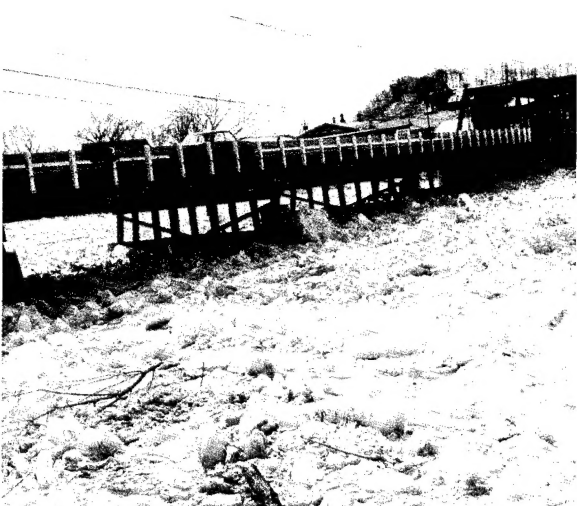
*Figure 4. Temporary piers subjected to ice forces in 1969.*

years (Fig. 4). Then why should it have failed? The most likely cause is deterioration of the structural integrity of the foundation due to the cumulative effect of scour. Several post-failure observations indicate that scour around the Bridge Street piers was the primary cause of failure, aggravated by the ice. The local newspaper reported that the bridge "seemed more flexible" to local commuters on the day of the failure. Also heard were comments on how good the fishing was underneath the concrete piers. The concrete used to encase the piles was cast directly on the riverbed, without a cutoff wall or bed protection.

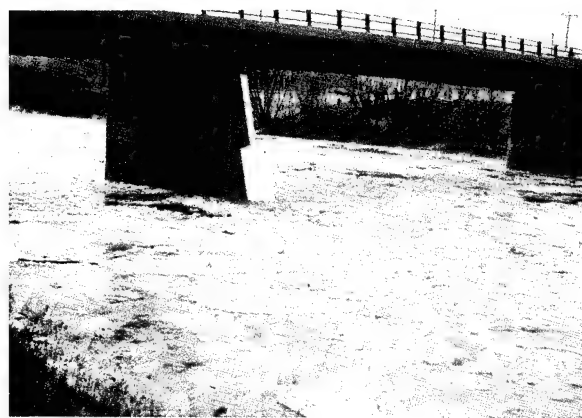
Figure 18. Ice conditions during breakup, March 10, 1992.
